Becky Addy Wood, Wiltshire

Draft Woodland Management Plan

Prepared for Bradford on Avon Town Council

17 July 2025

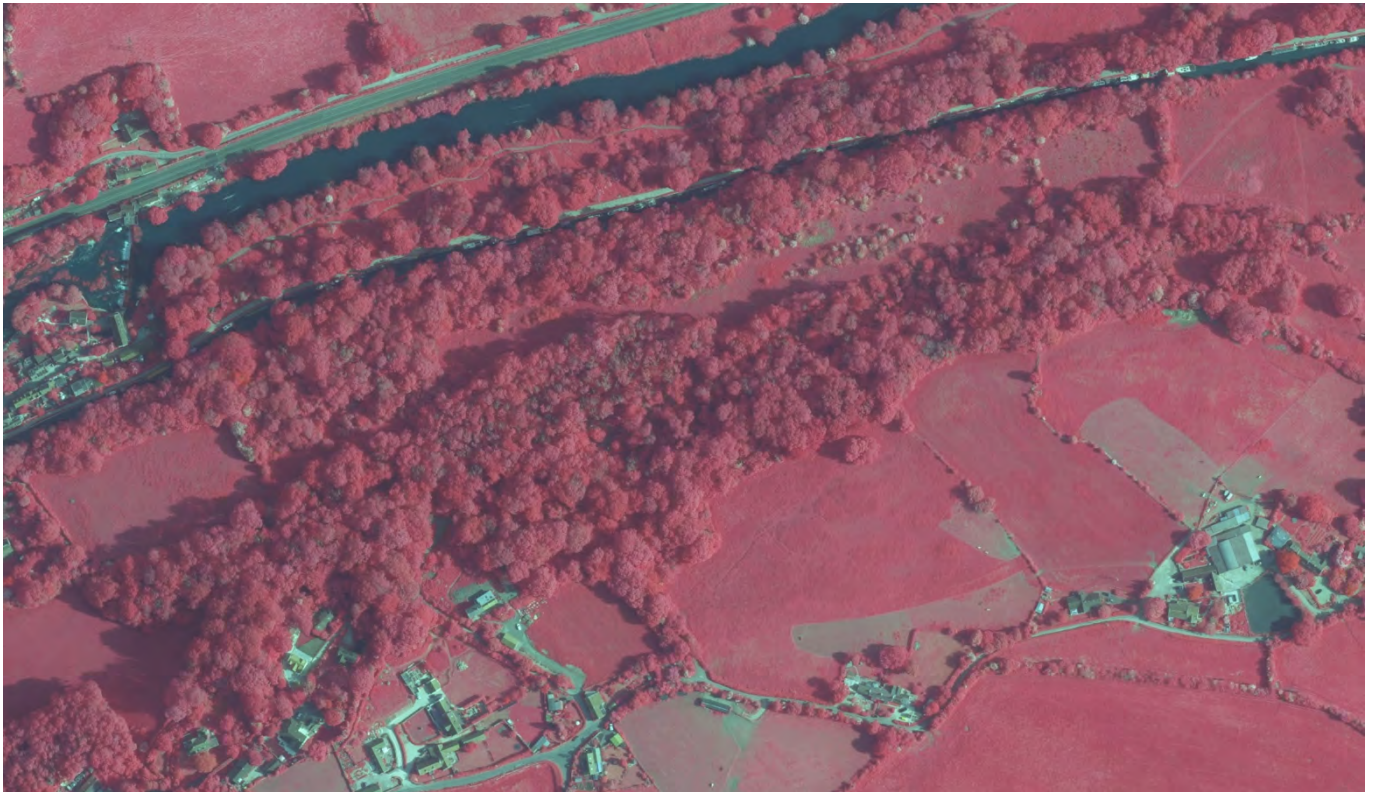
Plate 8: Infrared image of Becky Addy Wood

Plate 8 presents an infrared image of Becky Adilly Wood from 2023. Healthy vegetation reflects more near-infrared light than unhealthy or stressed vegetation. No formal coordination of this image has been made against ash trees, but it is not unreasonable to assume that the trees in Becky Adilly Wood that are more stressed from disease or other influences may appear less red.

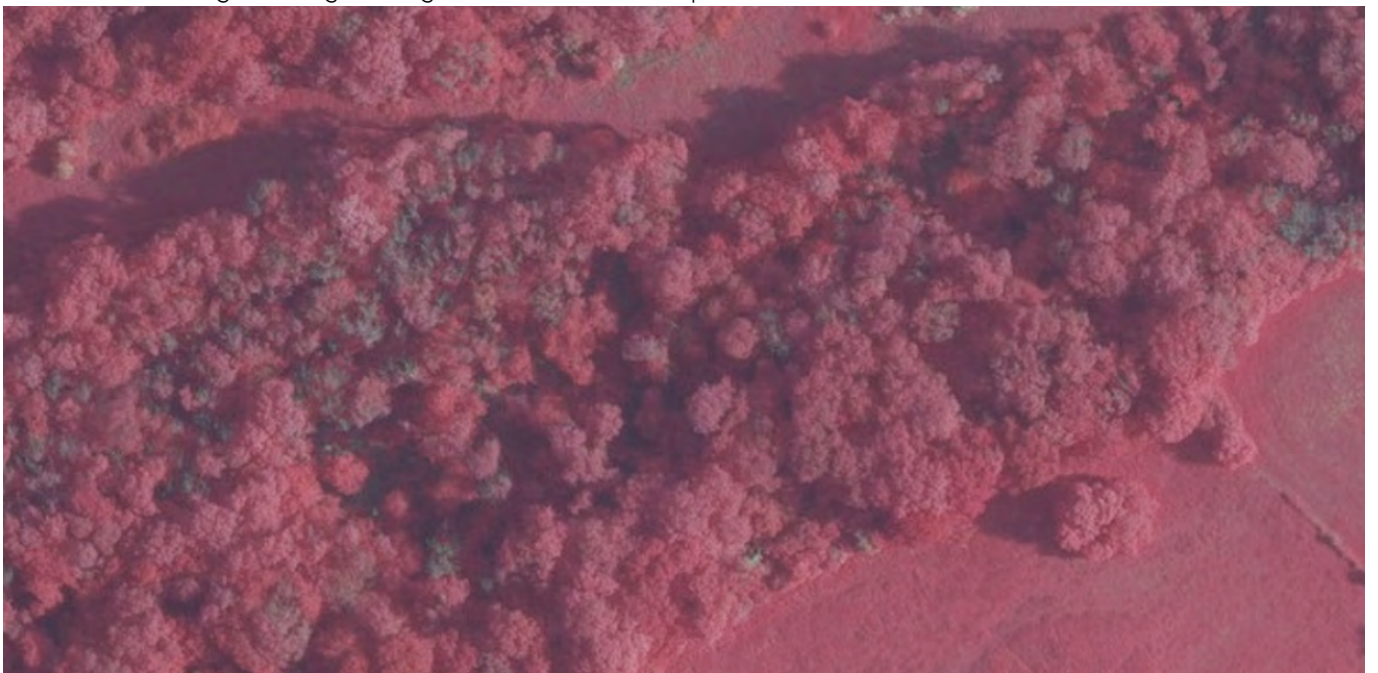
Plate 9: Infrared image showing differing levels of infra-red absorption and reflection

Plate 9 provides a closer view where individual trees with different levels of reflected infrared can be seen more clearly. This may highlight those trees with ash dieback or other pressures/stresses.

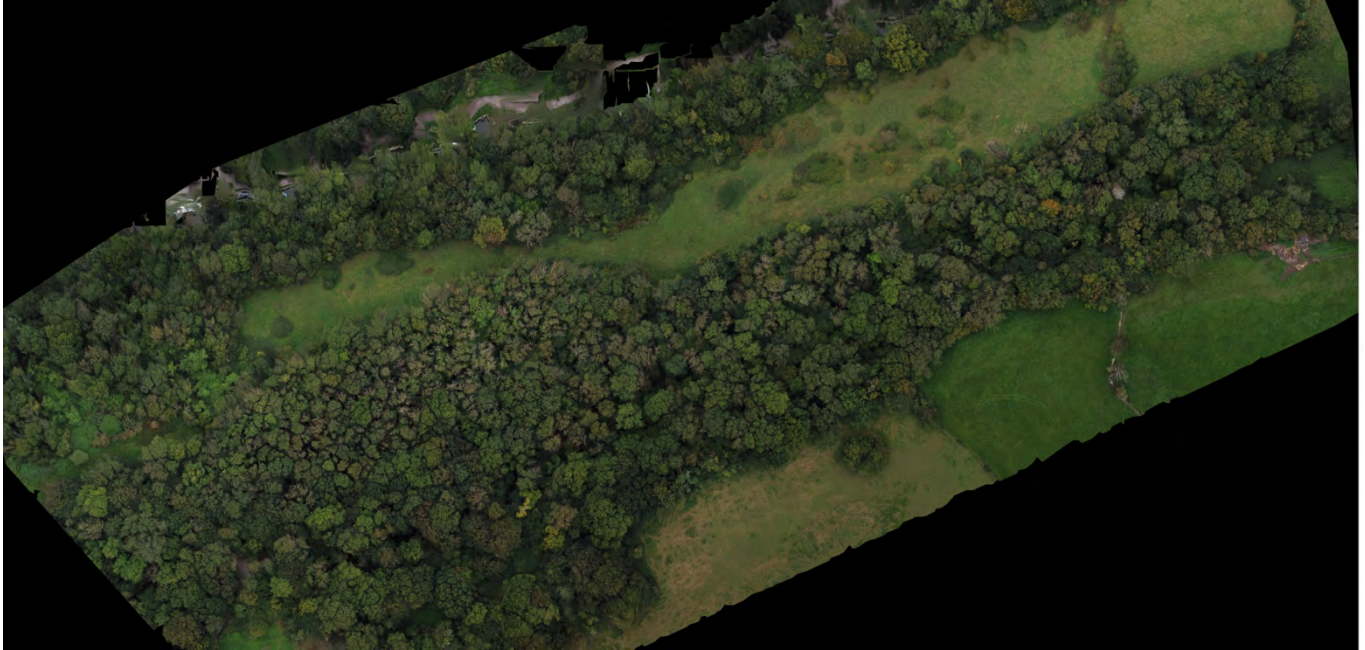
Plate 10: Orthomosaic image of Becky Addy Wood.

This can be compared to Plate 10, which is an orthomosaic image of Becky Addy Wood taken around the same time. Since then, further significant ash dieback has occurred with numerous fallen trees now present.

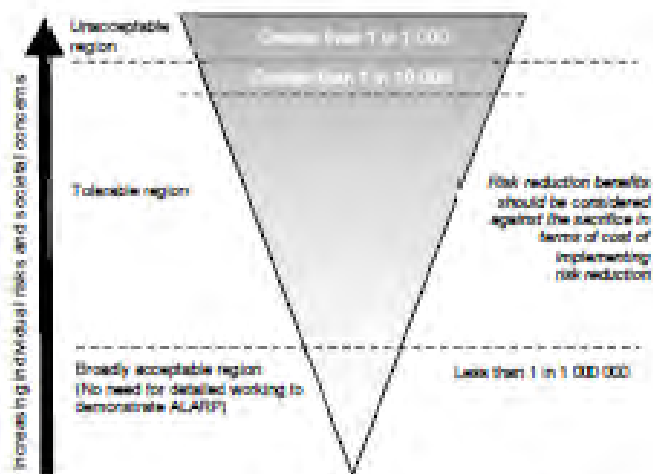
Fig. 1. Adapted from the Tolerability of Risk framework (HSE 2001).

By the roadside, with a target range of 3, a size range of 1 and a probability of failure of 3 the risk of harm is estimated at **1 in 100,000**.

Within the woodland, along the public footpath, with a target range of 4, a size range of 1 and a probability of failure of 3 the risk of harm is estimated at **1 in 400,000**.

3.14 Placing these estimates on the diagram below and within the traffic-light colours of QTRA (see **Appendix 3**) the risks posed by Becky Addy ash trees lie firmly in the tolerable region where risk reduction benefits should be balanced against the costs and risks associated with tree surgery. There is **no immediate emergency tree work required**. That does not mean that nothing needs to be done as it is possible to reasonably reduce the risks posed but this can be done in a planned manner, taking into account the long-term desire to retain a woodland at Becky Addy wood.

- 3.19 Thus, the need for emergency work is circumvented by the relatively low level of use of the public footpath and the even lower levels of use of the remainder of the woodland. The need for emergency works for trees near the road is not required at this stage, but as can be seen from the above calculations may not be far away if the condition of the live ash trees deteriorates further and/or further failure of trees is experienced.
