Bradford on Avon  
Town Council  
Becky Addy Wood  
Woodland Management Plan

# Becky Addy Wood, Wiltshire

## Woodland Management Plan Final

Date: 13 October 2025

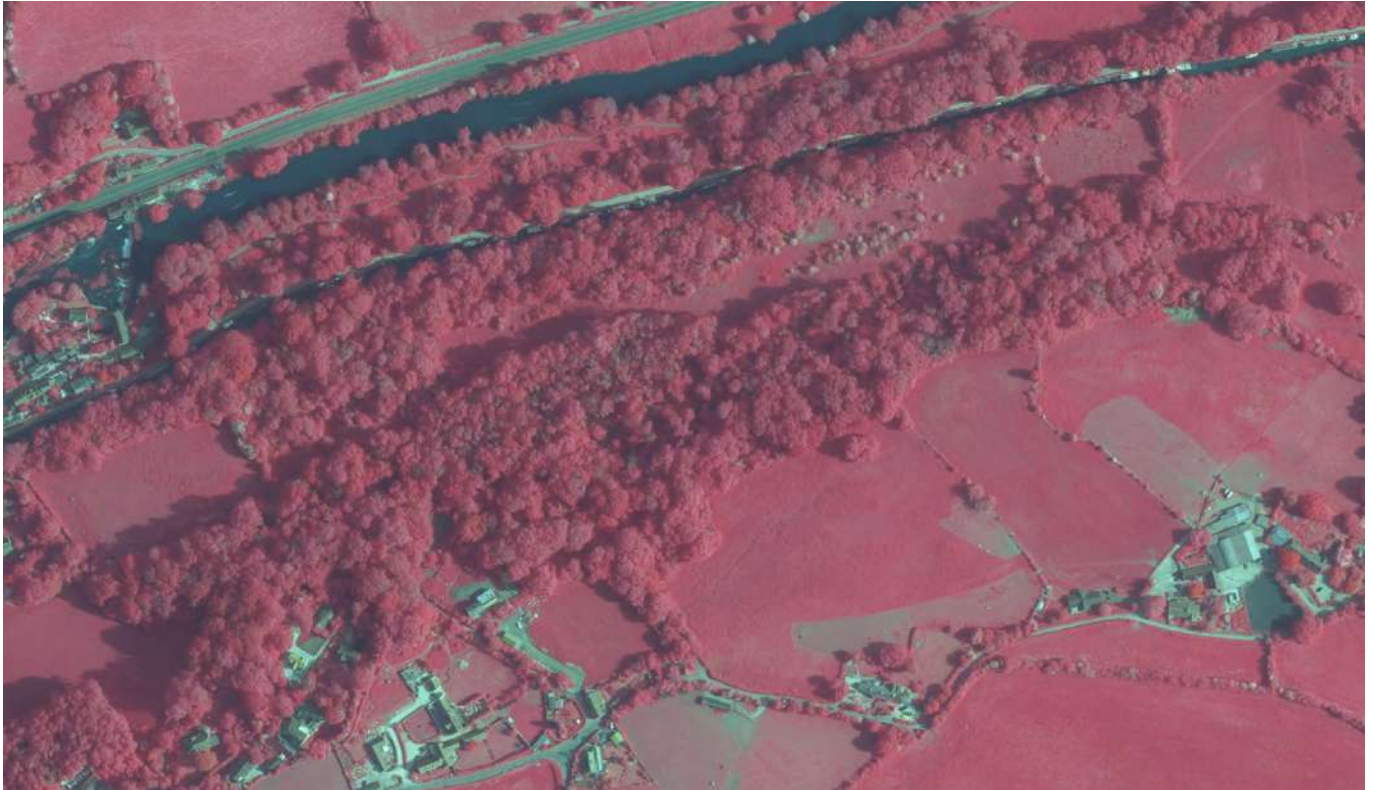
Plate 8: Infrared image of Becky Addy Wood

Plate 8 presents an infrared image of Becky Addy Wood from 2023. Healthy vegetation reflects more near- infrared light than unhealthy or stressed vegetation. No formal coordination of this image has been made against ash trees, but it is not unreasonable to assume that the trees in Becky Addy Wood that are more stressed from disease or other influences may appear less red.

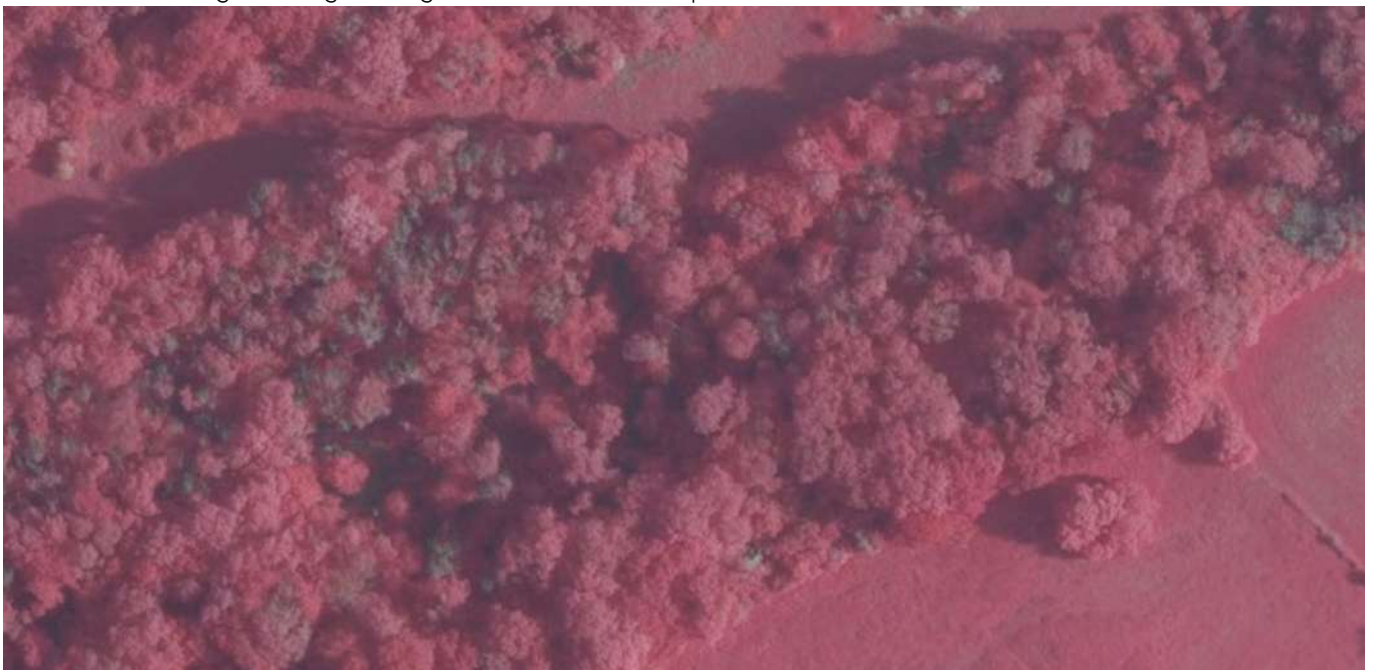
Plate 9: Infrared image showing differing levels of infra-red absorption and reflection

Plate 9 provides a closer view where individual trees with different levels of reflected infrared can be seen more clearly. This may highlight those trees with ash dieback or other pressures/stresses.

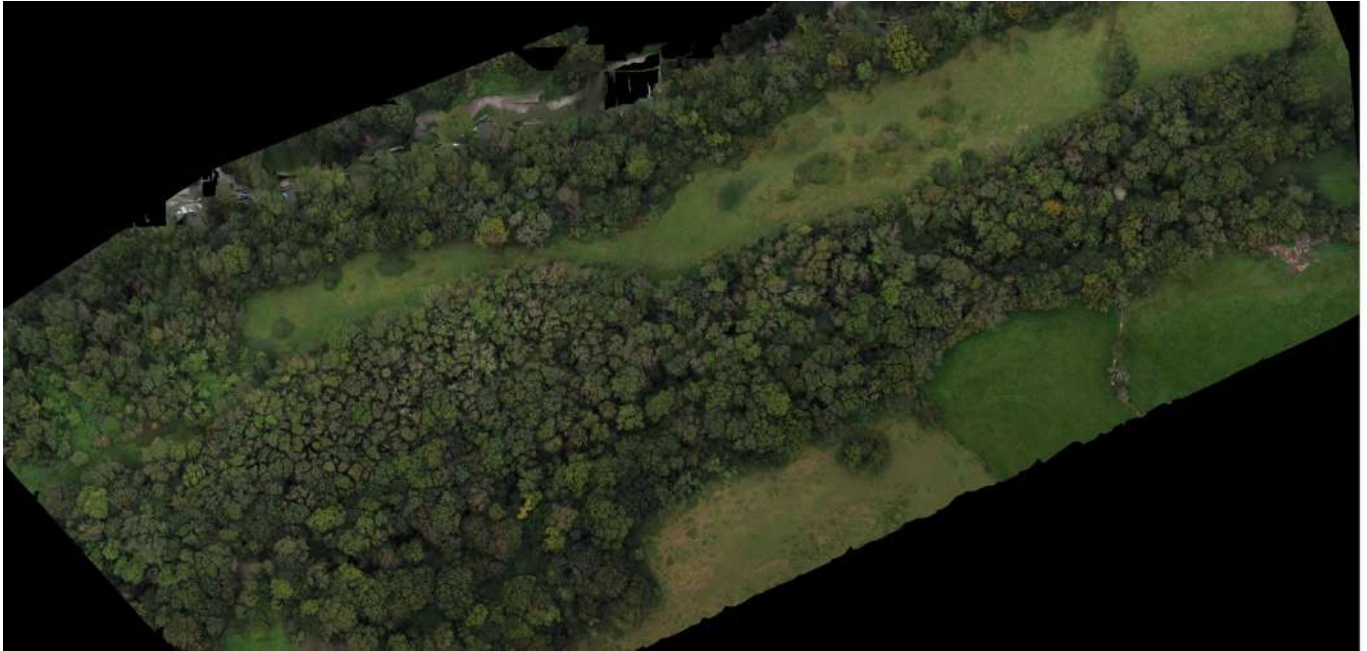
Plate 10: Orthomosaic image of Becky Addy Wood.

This can be compared to Plate 10, which is an orthomosaic image of Becky Addy Wood taken around the same time. Since then, further significant ash dieback has occurred with numerous fallen trees now present.

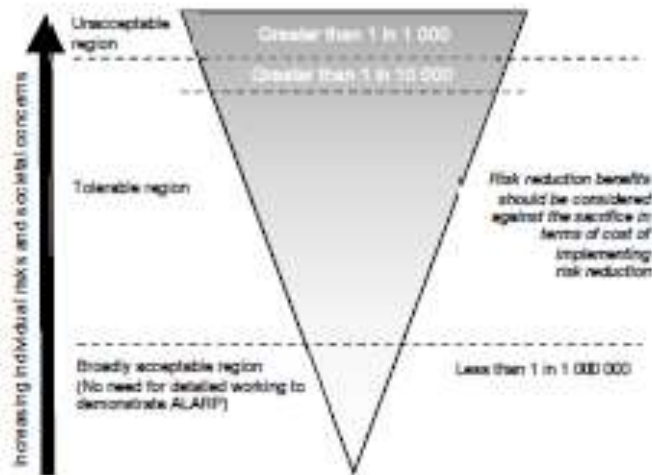
Fig. 1. Adapted from the Tolerability of Risk framework (HSE 2001).

- 3.13 Placing these estimates on the diagram below and within the traffic-light colours of QTRA (see **Appendix 3**) the risks posed by Becky Addy ash trees lie firmly in the tolerable region where risk reduction benefits should be balanced against the costs and risks associated with tree surgery. There is **no immediate emergency tree work required**. That does not mean that nothing needs to be done as it is possible to reasonably reduce the risks posed but this can be done in a planned manner, taking into account the long-term desire to retain a woodland at Becky Addy wood.
